### Division of Oil, Gas & Mining

### Inspection Report

**Mine Name:** Torrey Buff  
**Operator Name:** Quality Building Stone

**Permit number:** M0550022  
**Inspection Date:** April 5, 2006  
**Time:** 7:45-8:15 PM

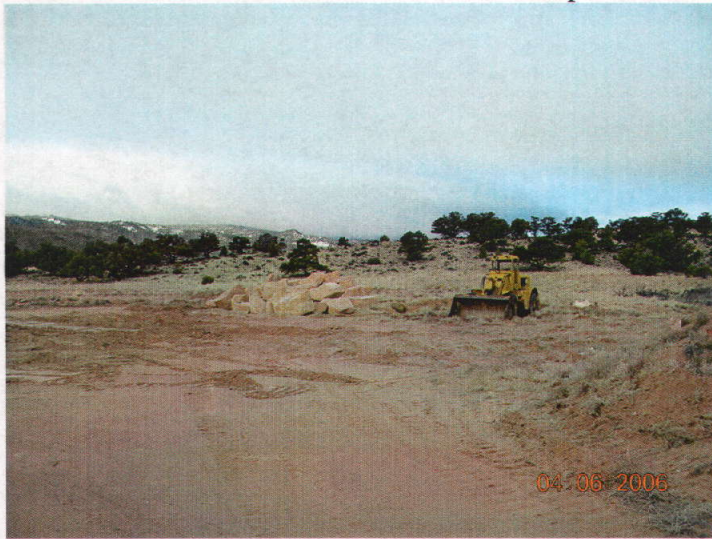
**Photo 1.** The stockpile/loading area near the mine.

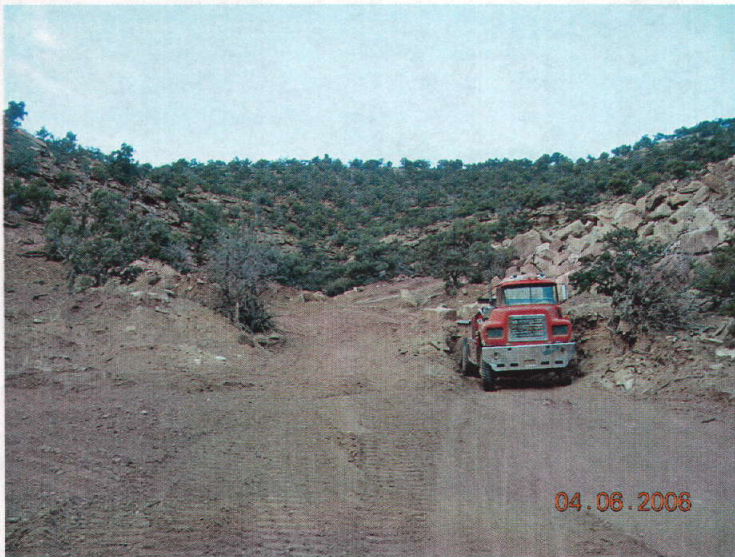
During previous inspections, there had been stockpiled stone and a truck in the bottom of the drainage that goes through the mine. The stone has been removed, and while the truck was still there, it was not right in the bottom (Photo 2).

**Photo 2.** Stone and the truck in this picture have been cleared from the very bottom of the drainage that runs through the quarry.

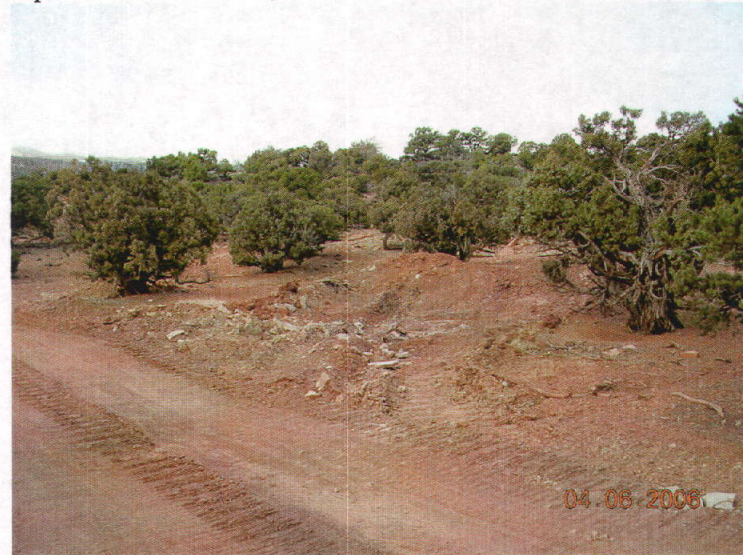
It appears the operator has been taking some stone from areas next to the road (Photo 3). There has been little disturbance, but these are not part of the disturbed area.

**Photo 3.** There are a few small areas outside the disturbed area where it appears the operator has taken stone.

The disturbed area is marked on maps in the notice and in the reclamation contract, and it does not include any areas along the access road. No mining should be done in these areas, and this includes picking up stone from the surface with mechanized equipment.

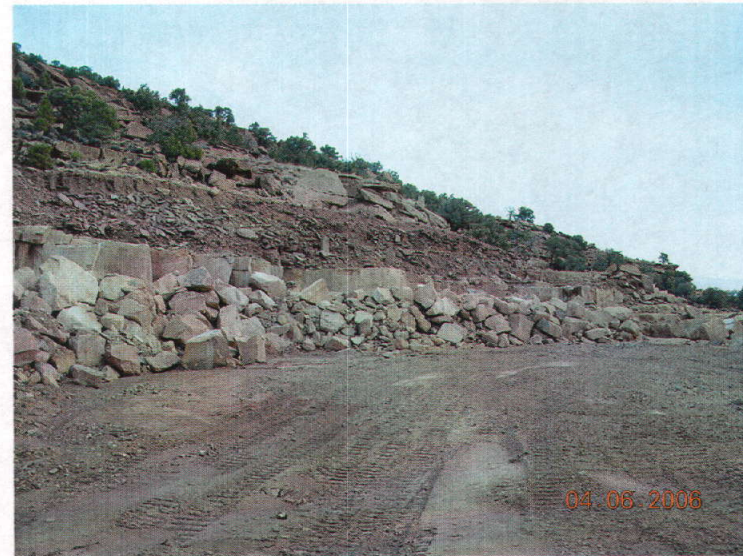
**Photo 4.** A highwall in the process of being reclaimed.
